2680A TROUBLESHOOTING HANDBOOK

Manual Part Number 02682-90910
Microfiche Number 02682-90810

JANUARY 85

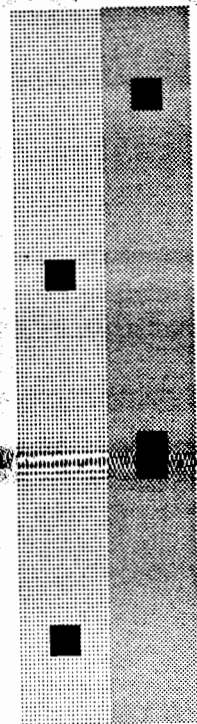
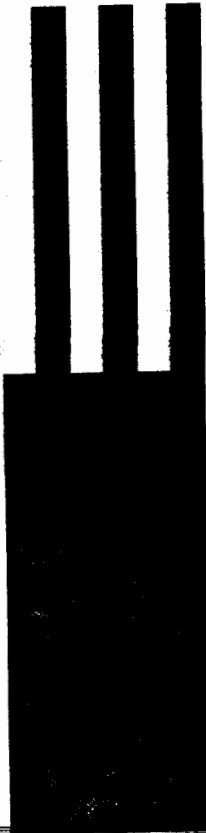
BACKGROUND (7)
This form of background was the result of an open pair of Primary Corona wires. This symptom occurred after approximately 50K drum rotations.

BACKGROUND (6) and BLOTCHES
Two print quality problems are evident in this print sample. The blotches on the edge of the self test pattern result due to a vacuum system failure. The heavy accumulation of toner near the center of the sample indicates weak cleaner blade tension. These symptoms began to appear at approximately 100K drum rotations.

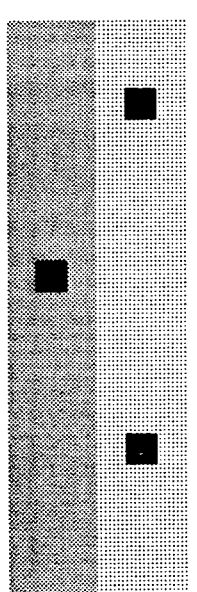
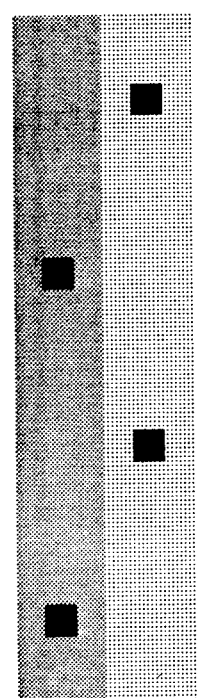
STREAKS/SMEARS (35)

This type of streak or smear is the result of an excessively worn retraction solenoid assembly.
