# PaintJet XL300

## Repair Guide

*Revision C*

San Diego Printer Division

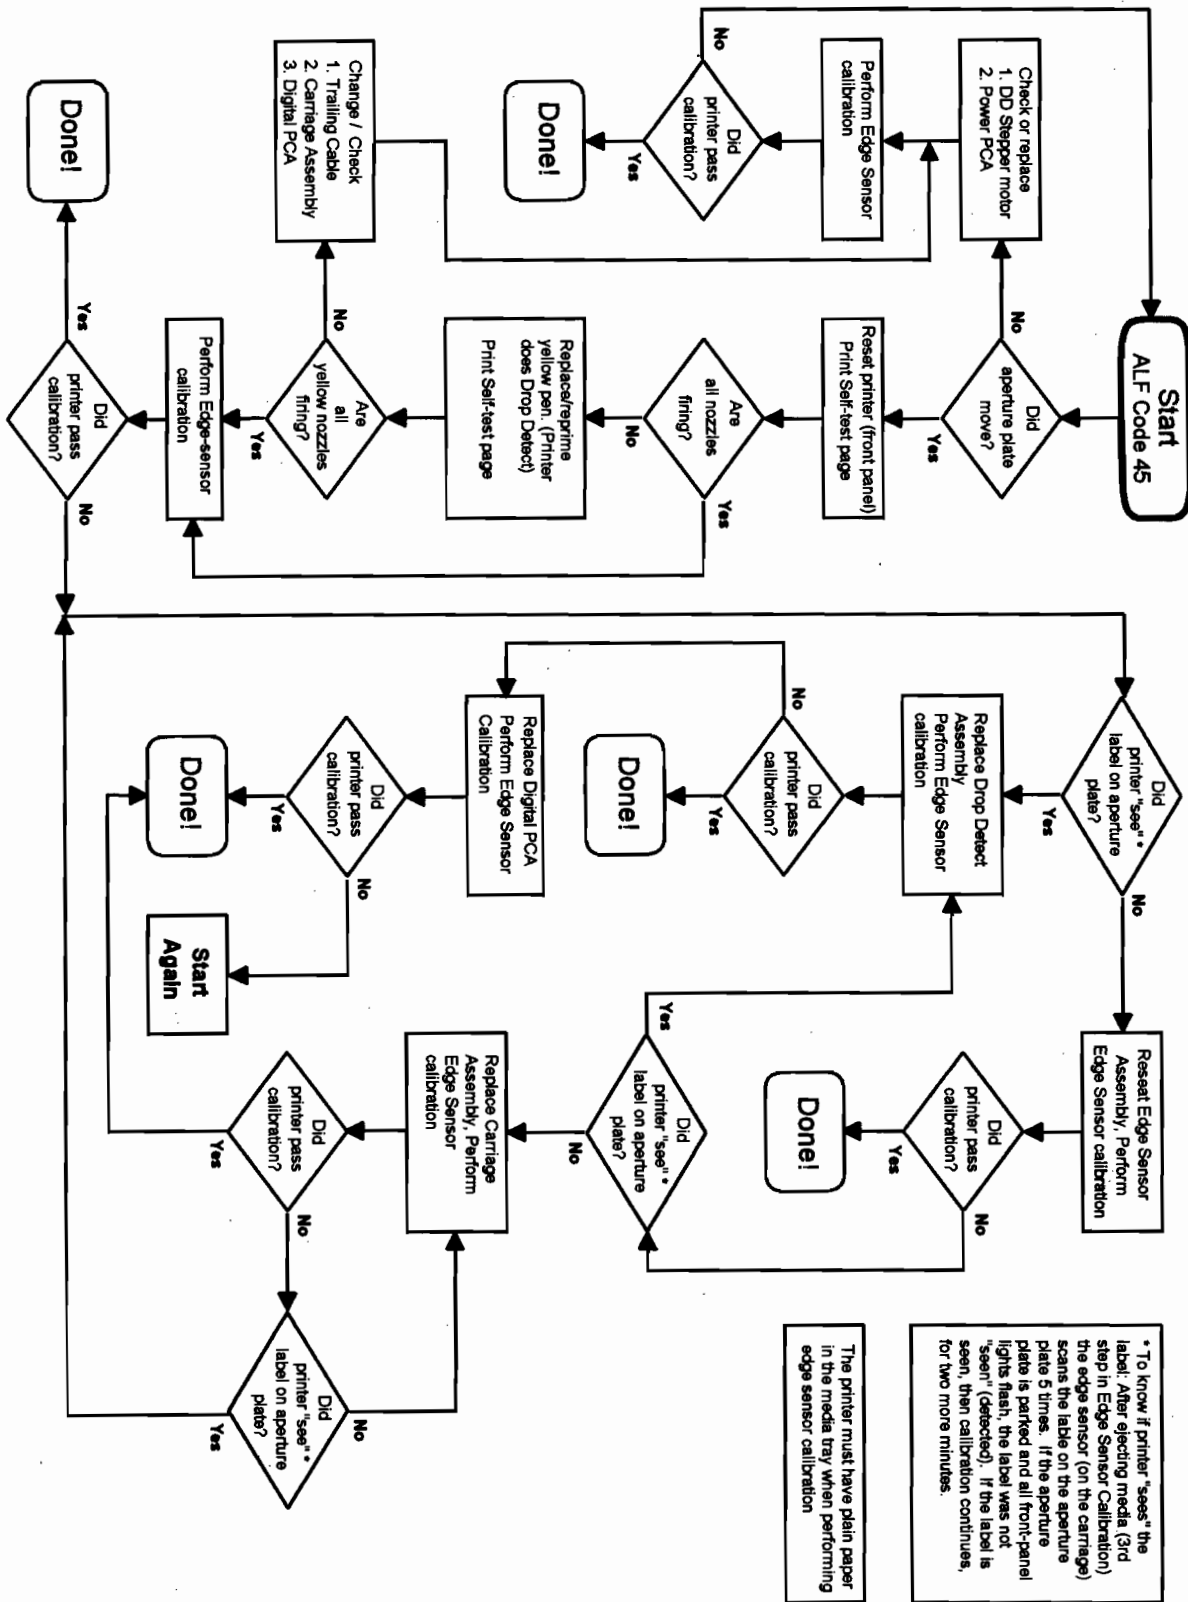
# Edge Sensor Calibration Error (ALF Code 45) Flowchart

Should the Edge Sensor Calibration procedure fail, the printer will go into a servo shutdown condition, with all front-panel lights flashing. The ALF code (see page 24) will be 45. Use the flowchart on the following page to diagnose the Edge Sensor Calibration error.

\* To know if printer "sees" the label: After ejecting media (3rd step in Edge Sensor Calibration) the edge sensor (on the carriage) scans the label on the aperture plate 5 times. If the aperture plate is parked and all front-panel lights flash, the label was not "seen" (detected). If the label is seen, then calibration continues, for two more minutes.

The printer must have plain paper in the media tray when performing edge sensor calibration

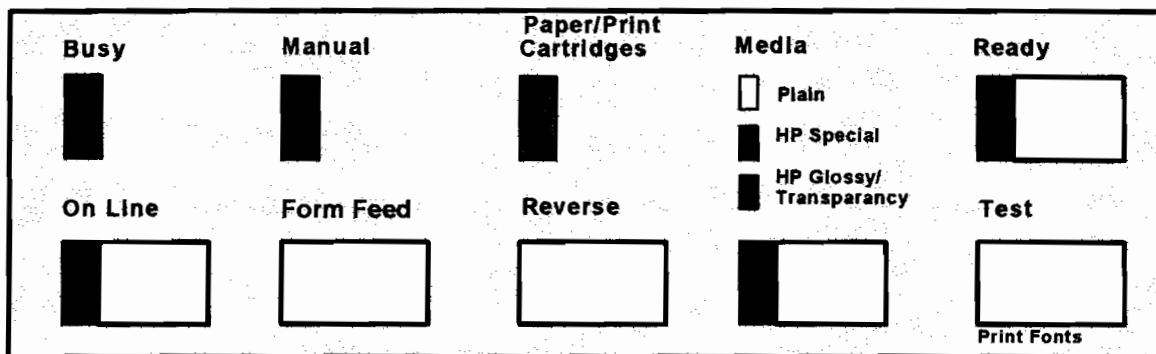
### PaintJet XL300 Front Panel ALF Codes

Code #	Possible Cause	Generated by
0	PB	Processor can not determine problem location.
1	PB	EAROM heater calibration constant; incorrect check value.
2	PB	During AC line sync, excessive heater feedback pulse detected while sampling line frequency.
3	PB	During AC line sync, excessive heater feedback pulse detected while verifying zero-crossing point.
5	RH/PB	Cannot determine difference between interlock open vs. interlock closed (probably roller heater fuse open or problem with Power PCA triac).
6	PB/DB	Excessive heater feedback pulse detected (roller heater selected but not driven).
7	PB/DB	Excessive heater feedback pulse detected (roller heater selected and being driven).
8	PB/DB	Excessive heater feedback pulse detected (grill heater selected but not driven).
9	PB	Excessive feedback detected under close loop control.
10	PB/DB	Shutdown for unknown reason.
11	PB	Excessive (>8) false pen access door open detects.

20	PB	Failed heater hardware FET test.
21	PB	Failed heater hardware TRIAC high line voltage test.
22	PB	Failed heater hardware TRIAC high low voltage test.
30	DB	Grill heater shutdown. Impossible state during page eject.
31	FF/PB/DB	Crossflow fan shutdown. Sensed crossflow fan on during Power-on initialization.
32	FF/PB/DB	Crossflow fan shutdown. Sensed crossflow fan off when it should be on.
33	FF/PB	Crossflow fan shutdown. Sensed crossflow fan on when it should be off.
34	DB/PB	Grill heater shutdown. Impossible state while printing.
35	DB/PB	Grill heater shutdown. Impossible state in main heater loop.
36	PB/CB/DCM/DB	Power-on shutdown. Failed to sense carriage move off right wall.
37	PB/CB/DCM/DB	Power-on shutdown. Distance between walls seems too short.
38	DB/PB	Grill heater shutdown. Impossible state during preheat.
39	PB/DB/PSM	Paper stepper motor shutdown.
40	DB/DCM/PB	Servo shutdown. Impossible servo state.

41	CB/PB/DCM/DB	Servo shutdown. Excessive velocity.
42	CB/PB/DCM/DB	Servo shutdown. Excessive position error.
43	DB/PB/PSM	Paper stepper motor shutdown. (Case #1).
44	PB/DB/PSM	Paper stepper motor shutdown. (Case #2).
45	DD/ES/CB/PB/DB	Edge sensor calibration failed. See flowchart on page 23
103	PB	Timeout while waiting to finish AC line sync.
104	PB	Failed line configuration/verify after 3 tries.

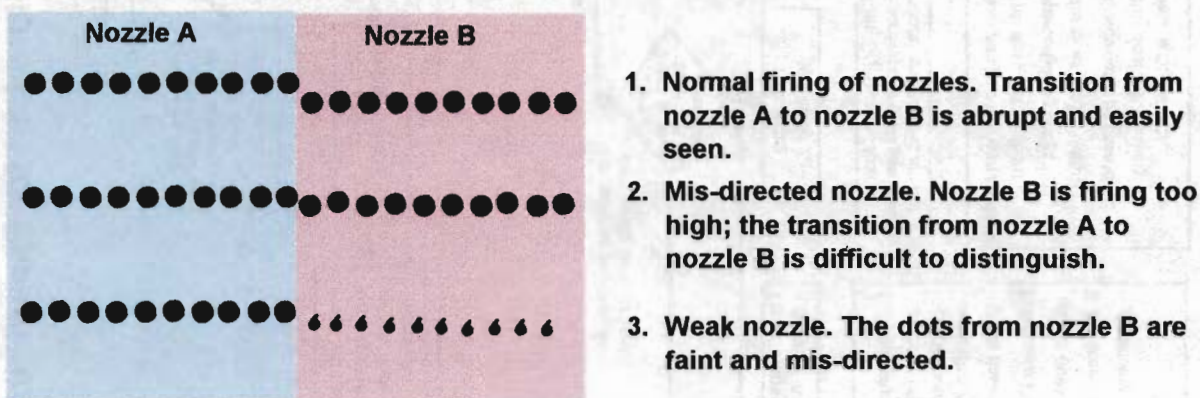
Following is a sample of how to interpret the nozzle test.

Mis-directed nozzle can be an inherent problem with the pen, or there may be contamination on the nozzle plate. A weak nozzle can indicate contamination or a low ink condition. A nozzle that is not firing, a "nozzle out," can be detected by the absence of a line of dots.

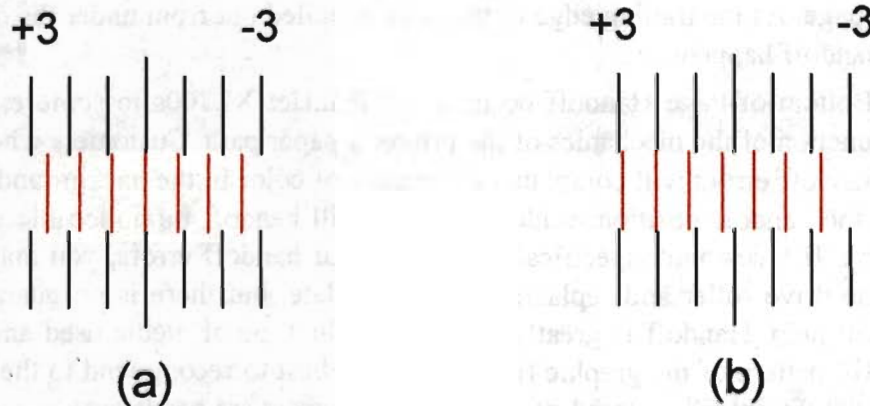
During the ink cartridge alignment process, selected nozzles are fired from each ink cartridge through a slotted aperture plate. The drops of ink fall past an LED-photo diode pair; the processor measures where in space the drops are falling with respect to the black ink cartridge, and from this information constants are derived. These constants are used during printing to adjust the timing of when the ink cartridges fire, ensuring that dots are placed exactly on top of other dots. A symptom of mis-aligned ink cartridges would be large areas of solid color, for instance green or red, that would have on one or two sides a "halo" of yellow (in case of green) or magenta (in case of red) where the two ink colors that make green (yellow and cyan) or red (yellow and magenta) are not being placed accurately.

The ink cartridge alignment verniers have lines numbered from +3 through zero to -3. The "units" of the verniers are dot rows. In (a) above is shown a vernier with no (zero) mis-alignment. The outside lines (black) match with the inside lines (magenta) to create one straight line at zero. In (b) above a two-dot mis-alignment is shown. The outside and inside lines make a straight line at +2, indicating a mis-alignment of two dots between those ink cartridges. Acceptable cartridge mis-alignment is no greater than plus or minus one dot row.

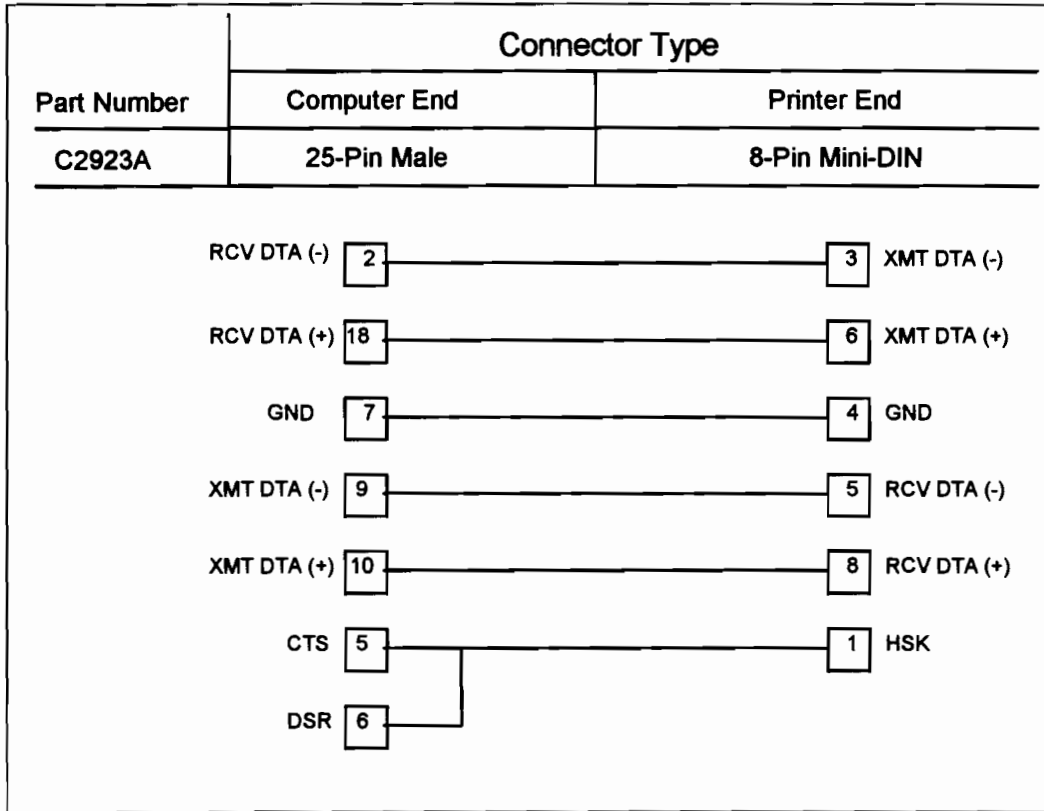
**RS-422 Cable**

The schematic diagram for the HP C2923A RS-422 cable given in the PaintJet XL300 User's Guide is incorrect; use the schematic shown below for RS-422 connections.

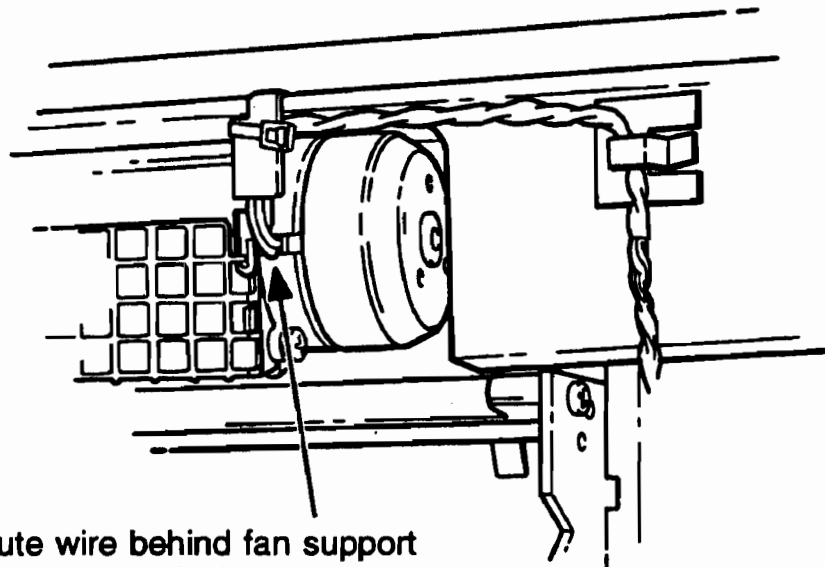
Beginning with serial number 3235A36618 the top cover (P/N C1645-60027) was modified to eliminate the problem of the fan wires being pinched by the top case. Even if a printer has this modified top case, re-route the wires when the front fan is replaced.

When replacing the front fan, route the wires as shown below in the illustration. Route the wires behind the fan support and secure the wires to the support with a tie-wrap to ensure the wires do not contact the fan rotor.

Route wire behind fan support and secure with tie-wrap.
