**OPERATING & SERVICE MANUAL**

**HP 37204A/B  
HP-IB EXTENDER**

Manual Part Number: 37204-90003  
Microfiche Part Number: 37204-90028

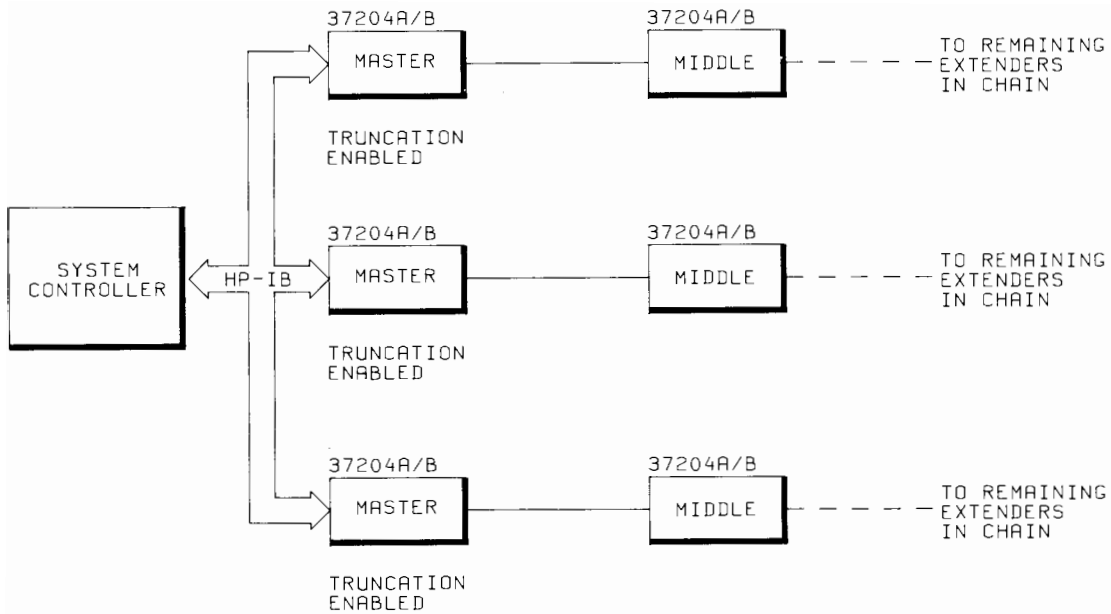
Figure 3-1 Truncation in Star Networks

Without truncation, failure in an Extender chain hangs everything. With truncation, the failing chain is truncated at the master Extender, allowing the rest of the system to operate normally.

Truncation is selected on the rear panel (see Table 2-1) and allows a partial HP-IB system to continue operating even with a failed Extender link. Without truncation, loss of communication between Extenders hangs the entire network because Extenders handshake every HP-IB transaction at all nodes.

The controller triggers truncation of a failed link by asserting IFC. Any Extender (with truncation enabled) which does not see messages being echoed back truncates the chain at the failing port (in the direction away from the master). Truncation remains active until the next time IFC is asserted at which time the echo check is repeated.

Truncation enabled only at the master Extender always truncates the chain at the master. Truncation may also be enabled at all Extenders but, in this case, **fiber links are not allowed.**

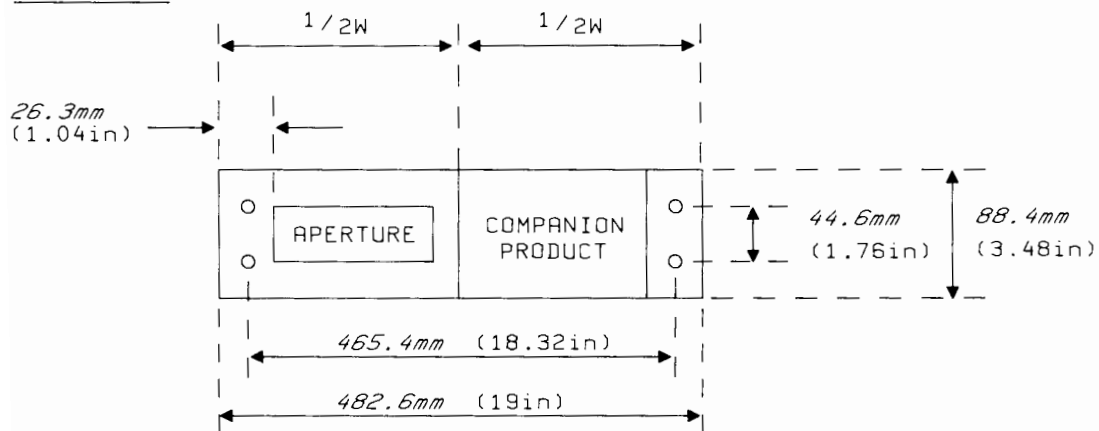
HP 37204A/B: APPROXIMATE PHYSICAL DIMENSIONS

HOLE'S ARE OBROUND:  $7.9 \times 11.1\text{mm}$  (0.31 x 0.44in)

APERTURE:  $210 \times 61\text{mm}$  (8.27 x 2.4in)

TOP

Weight:  
1.72kg

SIDE

FRONT and REAR
