98407A 512K-byte Memory Assembly

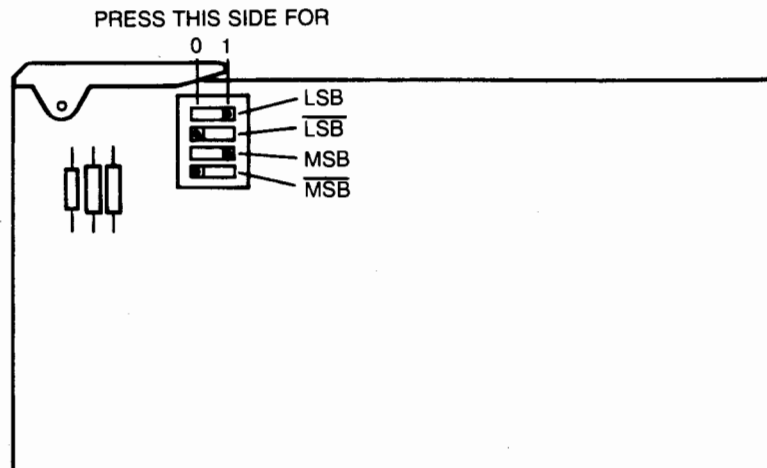
Block Select Configuration Switches

To set the block address for each board, position the appropriate address switches in the upper left corner of the board as indicated in the table which follows. There are two pairs of switches in the cluster, and each switch within a pair must be set OPPOSITE to the other as shown. Configure the boards, starting with Block 20 and adding Block 40 and 60 up to the maximum memory being installed. Be sure switch rockers are firmly sealed in their proper positions.

Blocks	MSB	$\overline{\text{MSB}}$	LSB	$\overline{\text{LSB}}$
20-36	0	1	1	0
40-56	1	0	0	1
60-76	1	0	1	0

Before any new memory assembly is installed in the HP 9845B/C, it must be set up to respond to the correct block-select address range when selected by the CPU. Three configurations are available, and each board must use one of the three possibilities shown. Any other combination of settings results in improper system behavior. Note that no two boards may be set to the same address range.
